Manhole Inspection Summary

Manhole # S27K__008MH

Insp Date: **6/4/08 9:25 AM**

Location Address: **329 S Poppleton**

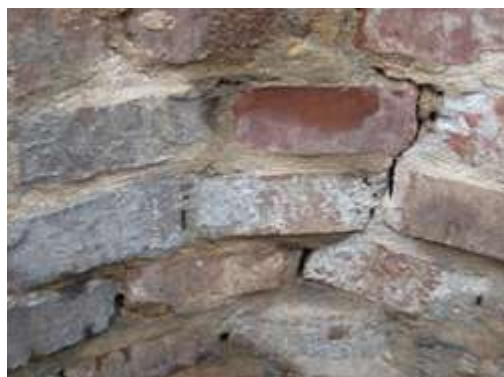
Defect 7

Condition: ☐ Sound ☒ **Cracked** ☐ Root Intrusion ☐ Loose Brick ☐ Deteriorated

cracked corbel bricks

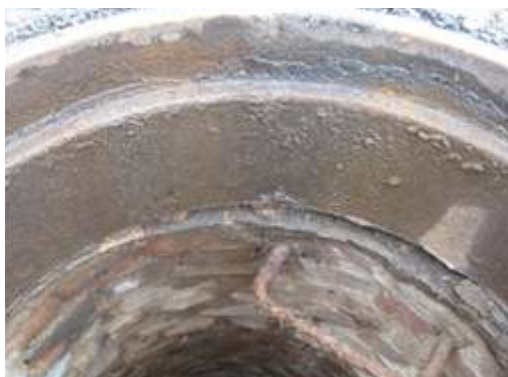
Defect 6

Condition: ☐ Sound ☐ Cracked ☒ **Leaks**

frame-lid infiltration

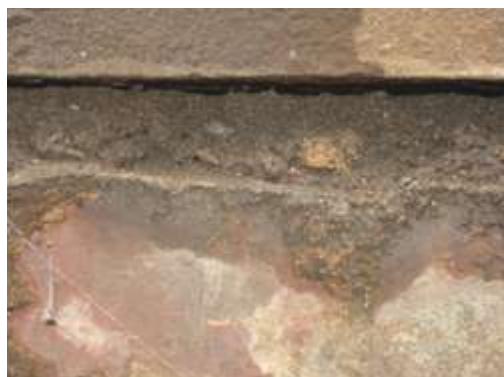
Defect 5

Infiltration: ☐ None ☐ Joint ☒ **Cracks** ☒ **Mortar** ☐ Roots ☐ Wall

missing mortar, infiltration joint frame-lid

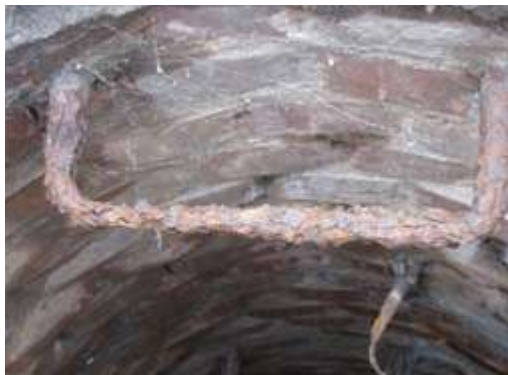
Defect 3

Count: **6** Missing: **2** ☒ **Corroded**

corroded and missing rungs

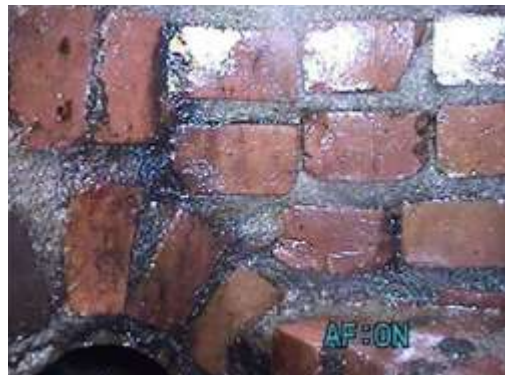
Defect 2

Infiltration: ☐ None ☐ Joint ☐ Cracks ☒ **Mortar** ☐ Roots ☒ **Wall**

infiltration barrel

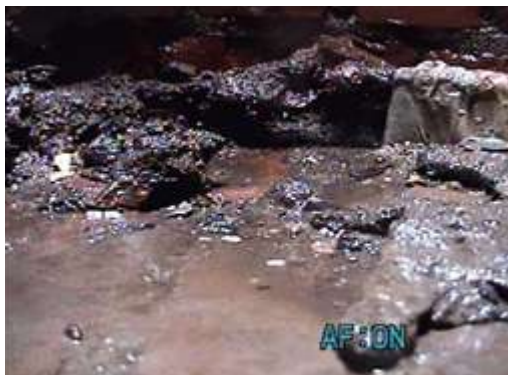
Defect 1

Condition: ☐ Sound ☐ Cracked ☐ Root Intrusion ☐ Deteriorated ☐ Leaks ☒ **Debris**

debris on bench

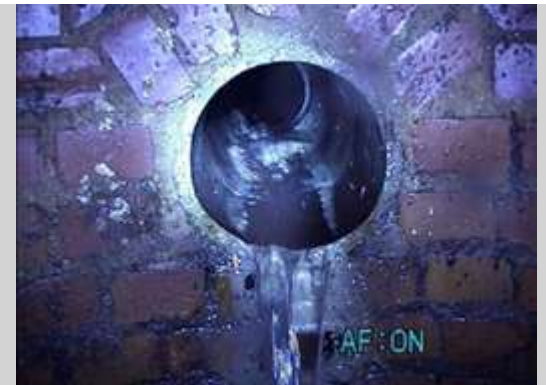
6 O'Clock Inflow

Pipe Height: **7.2** (in.) Rod and Bar (Angled)
Pipe Material: **Clay** ☐ Pipe Lined
Invert Depth: **8.83** (ft.) Flow Characteristics: **Fast**
Deposits: ☒ None ☐ Mud ☐ Sludge ☐ Debris ☐ Grease
Silt Depth: **0** (in.) Deposits Extent:
Infiltration: **None** Pipe Seal Cond: **Sound**

Drop: **Outside** Rod and Bar
Angled: **Yes** Reading: **9.70** (ft.)
Inv Depth: **10.70** (ft.)

Drop Condition: **Open**
